Hervan asemakaava

Rakennettavuusselvitys

Sitowise Oy - Granlund Oy - Arup

Liite 14 | 2. huhtikuuta 2026

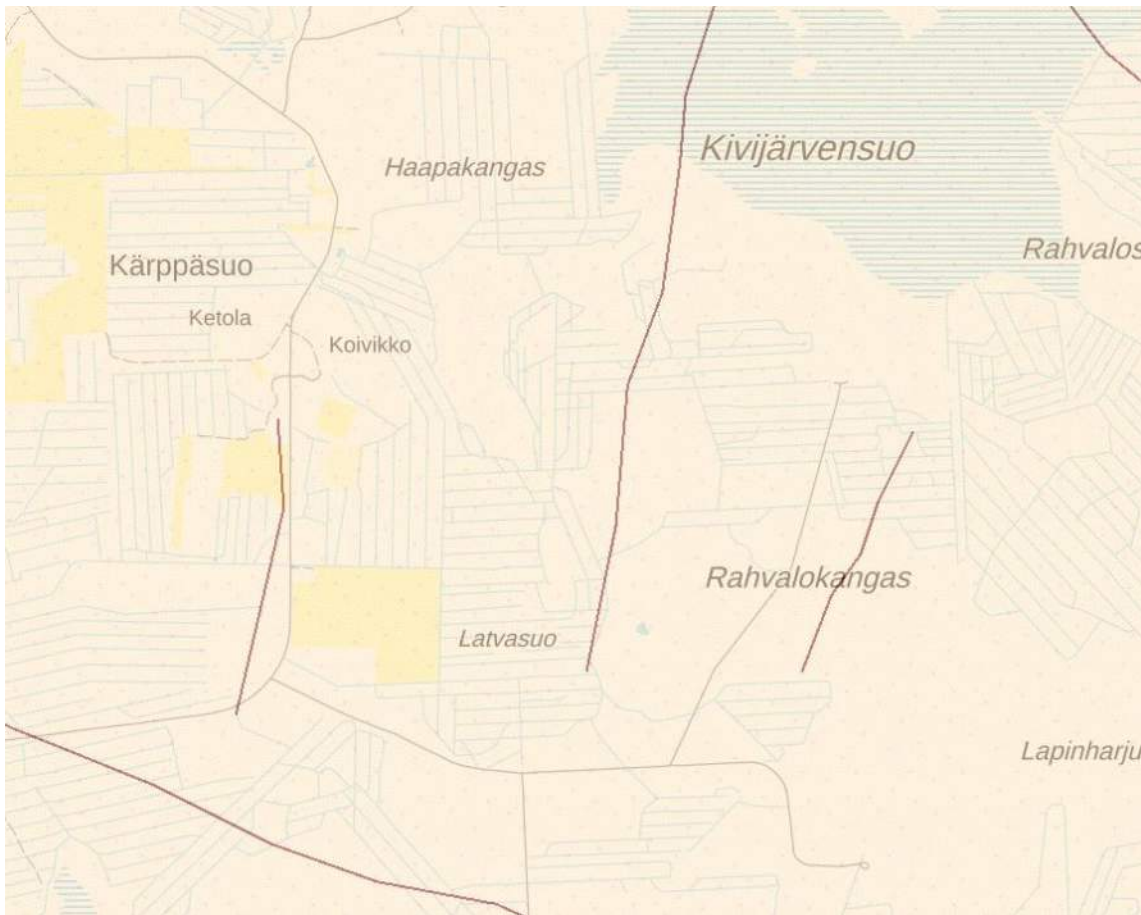
Figure 4. Caption from bedrock map, Geological Survey of Finland (GTK). (captured 25.11.2024). Light brown area (whole area) represents migmatitic tonalite and brown lines are diabase veins. The description mentions that the brown line down in the left corner might also contain gabro.

The main rock types of the mapped area (Figure 4) are migmatitic and tonalitic gneisses. Intrusive rocks, mainly diabbases are abundant. In the following chapters, each rock type is described using both literature and field observations.

Migmatitic and tonalitic gneisses (Figure 4, Area 1) form the base of the research area and are Archean in age according to literature. The samples from moraine show slightly-moderately banded textures but also tonalitic or granitic compositions without remarkable schistosity. Quartz veins are sometimes cutting the gneiss and some quartz rocks can be found sparsely (Figure 5, Area 1) (massive quartz occurs as veins in gneisses).

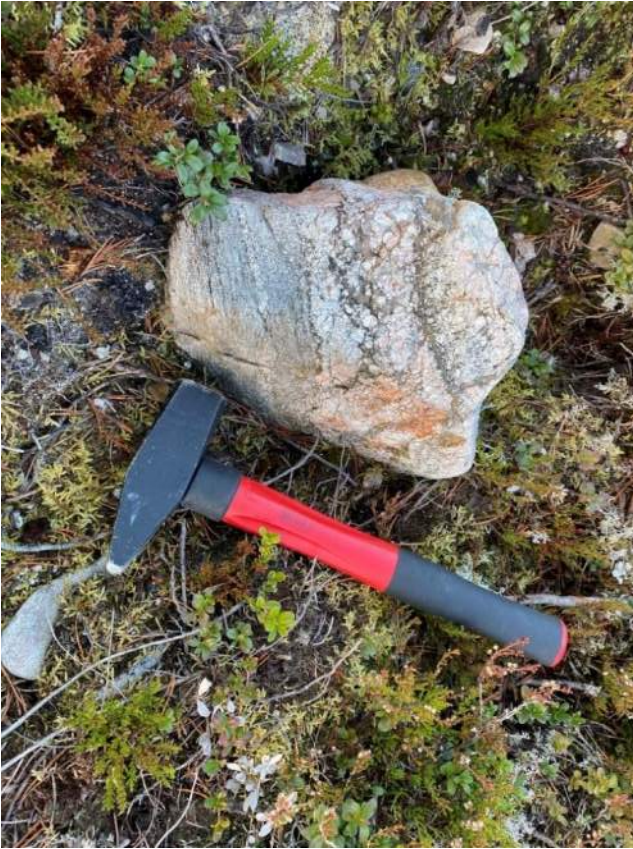
Figure 5. *Tonalitic gneiss sample from moraine. Both neosome and leucosome (tonalitic) are visible.*

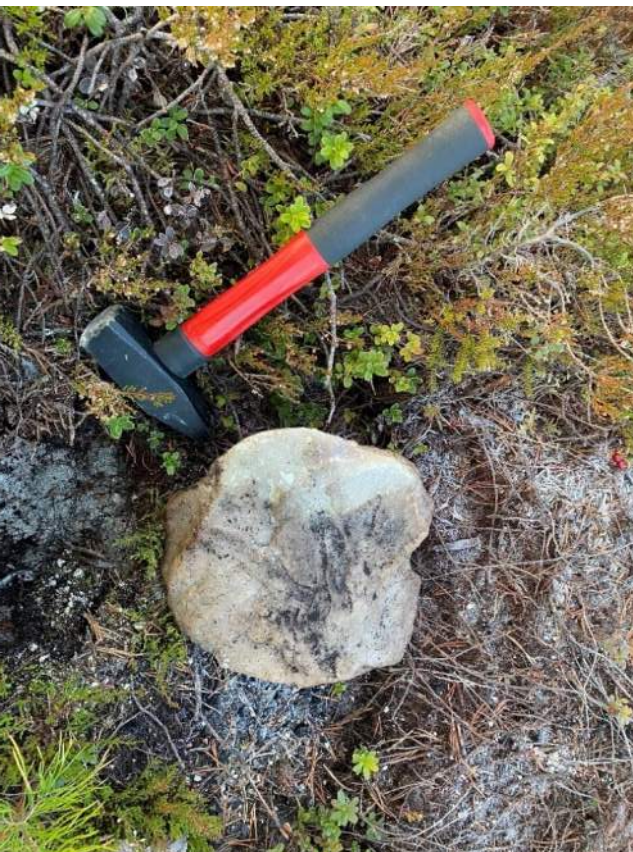
Figure 6. *Quartz sample from moraine.*

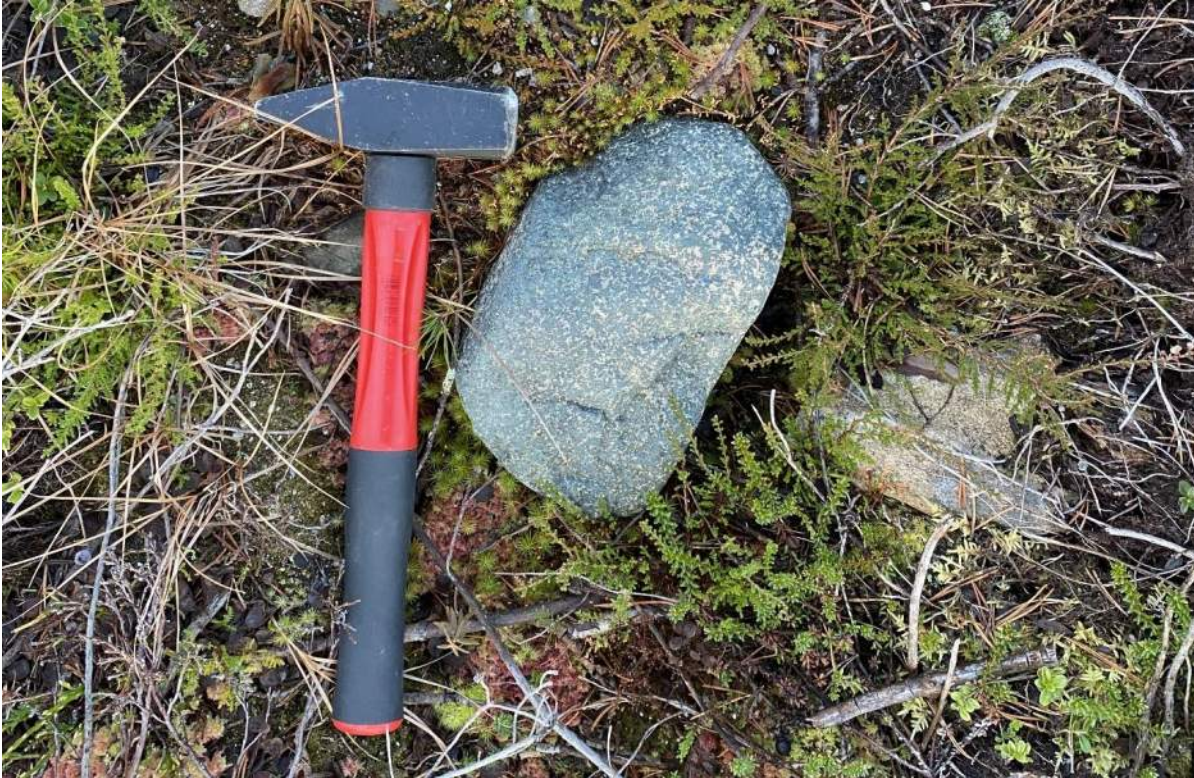
Figure 7. Diabase rocks are also found from the moraine.

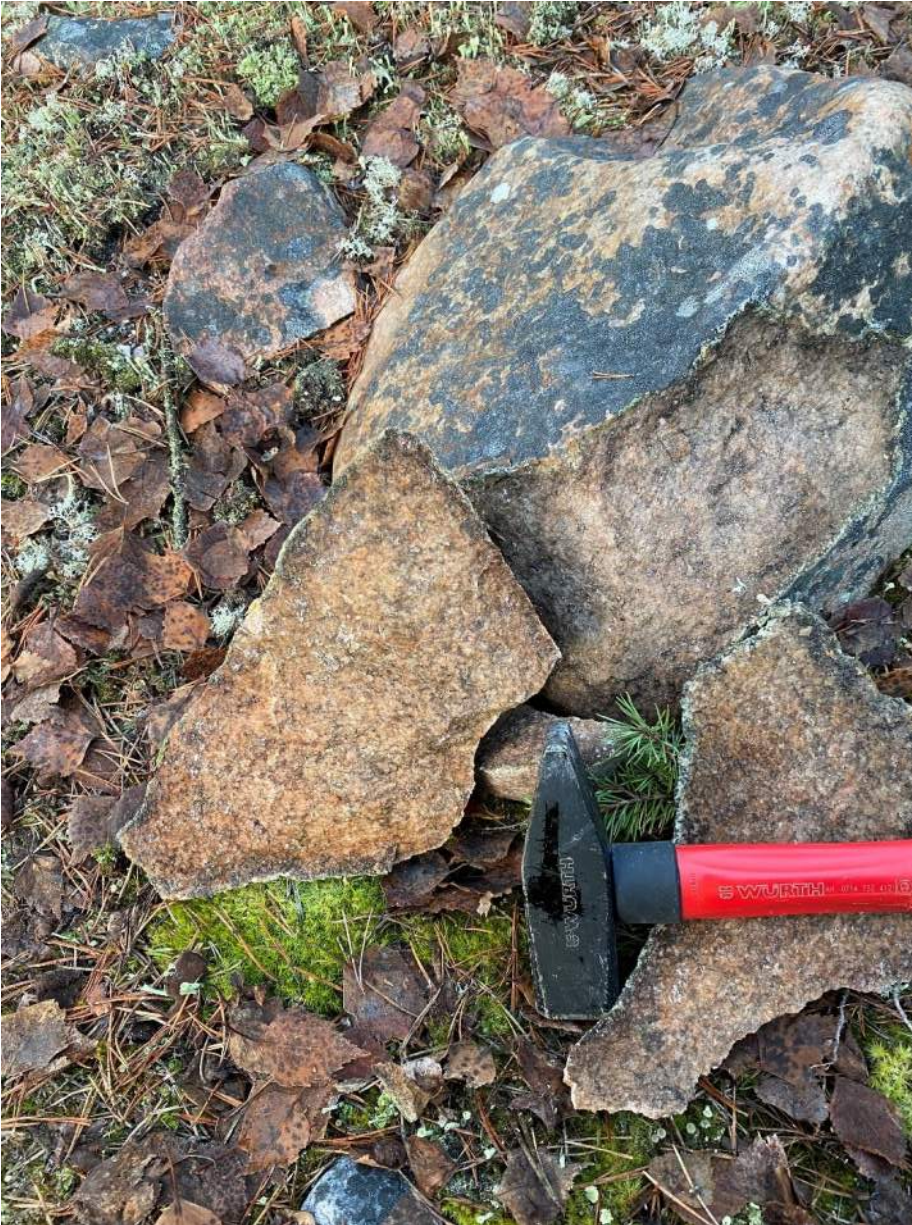
Figure 8. Granite sample from the research area.

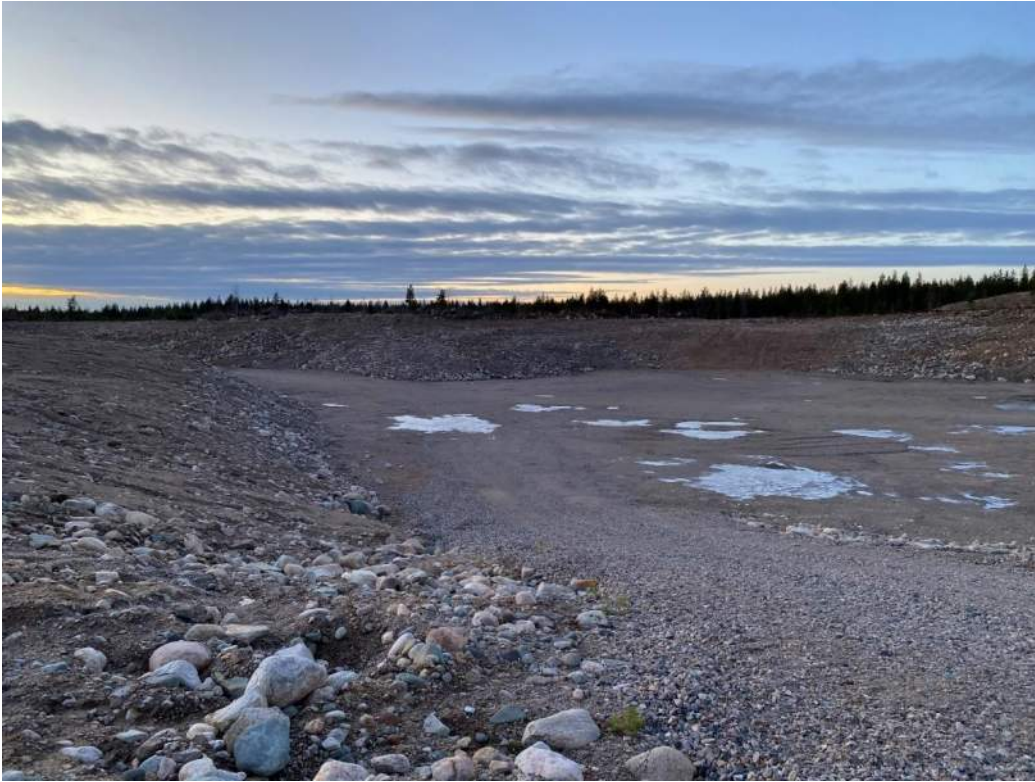
Figure 9. Konttikangas gravel pit.

As an objective, it was asked to visit economical scale gravel pits (Figure 9, 10) South from the site area. There were three pits and two of those were active. All pits were processing sand-gravel-boulder sized materials. The main idea was to find bedrock, because the pits are estimated to be 10-15 m deep in the deepest points. However, the bedrock was not exposed to the pits. Konttikangas area gravel pits (two of the pits were in the Konttikangas area) are located 1,4 km S-E from the site area and that is the glacier ice flow direction. The rock types are however the same in the site area. Maybe more tonalitic and granitic material than at the site, but not with the big difference.

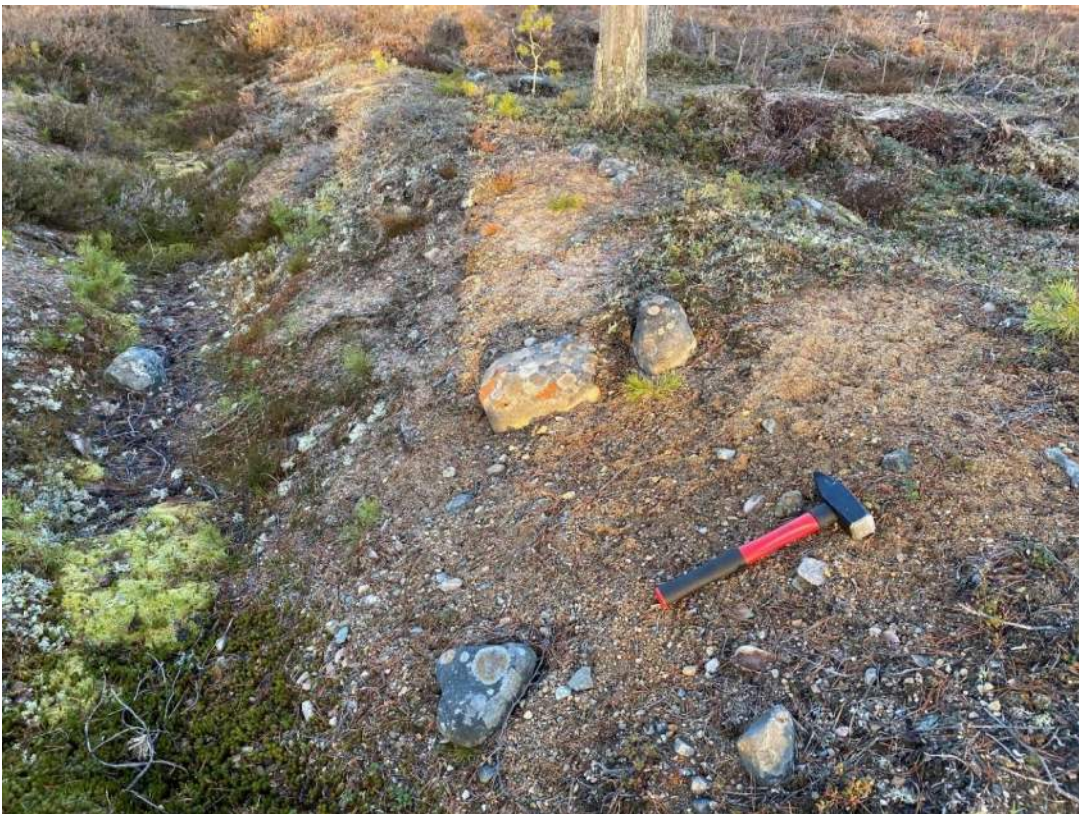
Figure 11. Sandy till is exposed to the edge of the drainage ditch.

The site walk started from the Southeast corner of the site map. The first objective was to confirm the existence of the sandy till. A coarse-grained sandy till was exposed in many places near the drilling point H17 (Figure 11, Area 1). **Sandy till contains approximately 50% sand, 30% gravel and 20% boulders. This can of course vary a lot. Biggest boulders are usually 1-2 m in diameter. The sandy till grains are mostly rounded.** There was a W-E oriented ridge a little bit North from the drilling points H01 and H02 which showed characteristics of a paleoshoreline (Area 2). The till's finest material is probably washed away in this area. Nearby drilling points H18, H19 and H17 the vegetation and water conditions are noticeable sensitive to ground level changes or changes in till composition. A fine-grained till is not letting water through, when swamp vegetation and wet conditions are formed.

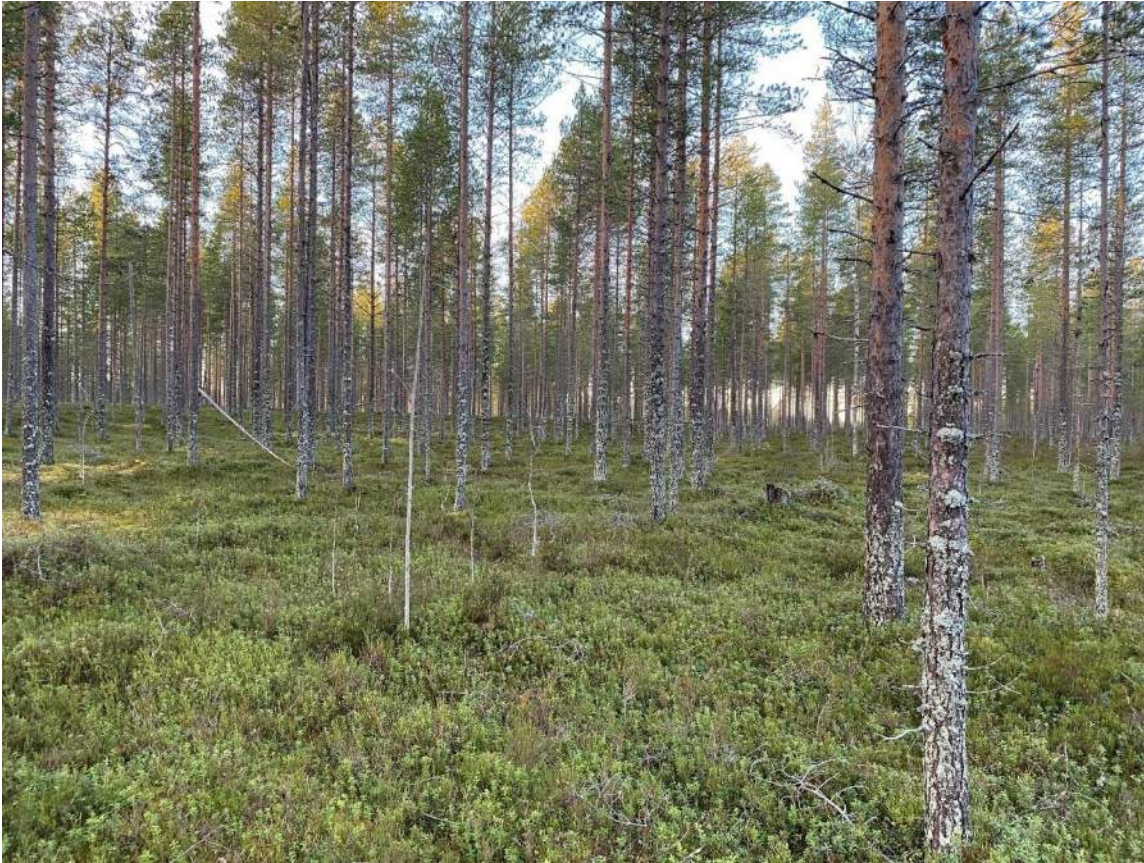
Figure 12. *The probable paleoshoreline area shows undulating formations (shoreline sand or sorted sandy till) around the ridge.*

Most of the research area consists of sandy till (Figure 12). When driving on the smallest roads in the site area, most of the time sandy till can be seen in the ditches (Figure 13, Area 9). Large areas of sandy till are exposed to the surface in the power line construction works Eastern side of the research area (Figure 14, Area 5).

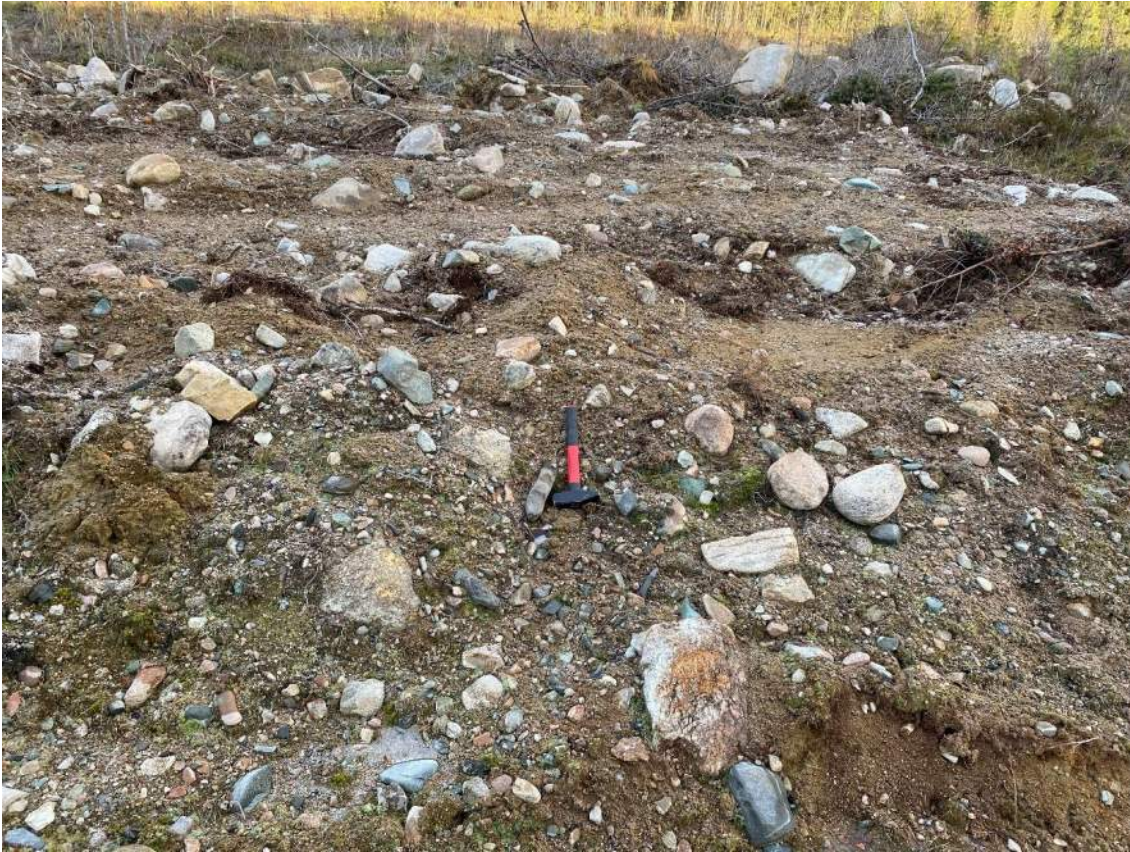
Figure 13. Sandy till in the power line construction site.

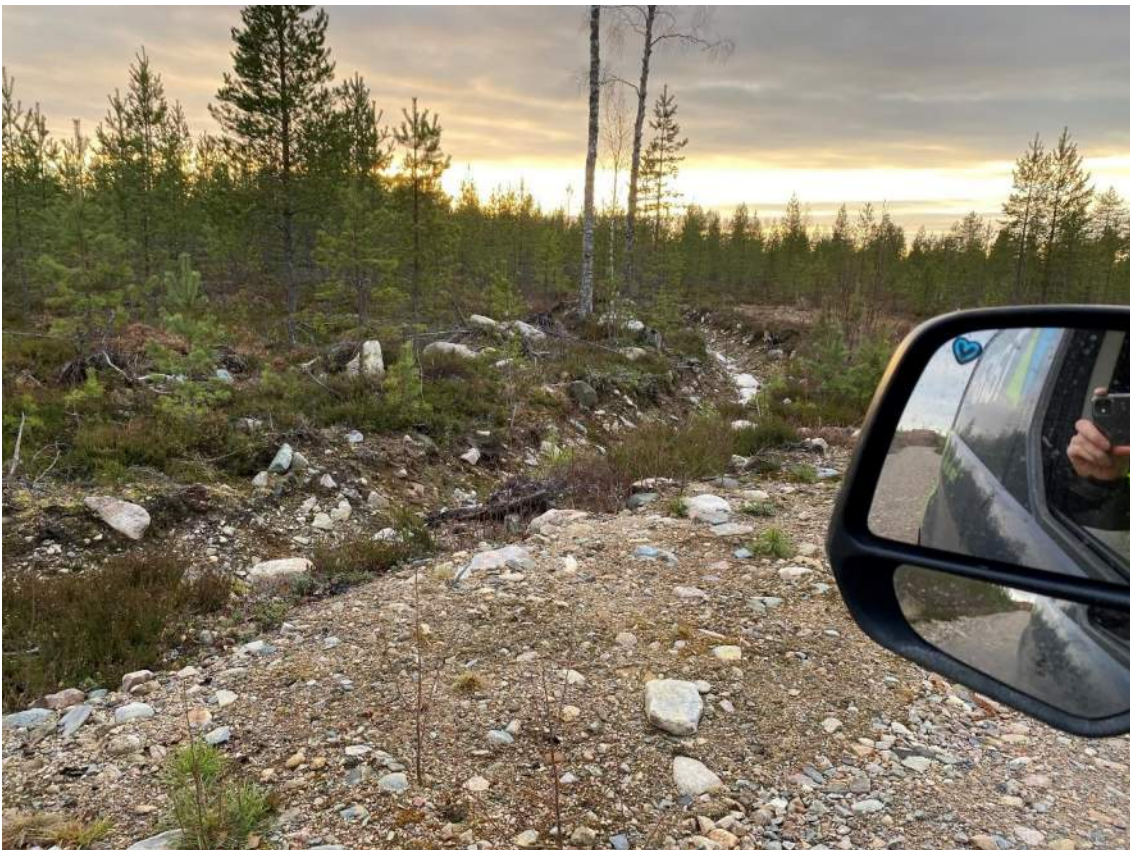
Figure 14. Sandy till is exposed widely to ditch walls.

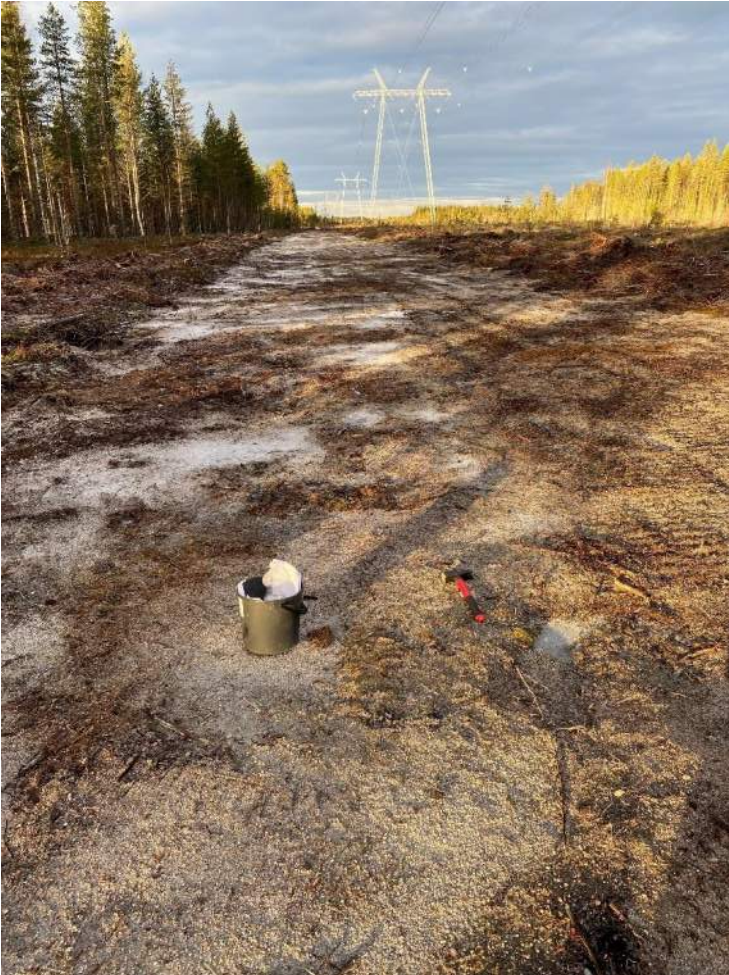
Figure 15. Coarse sand is widely exposed to the power line construction site.

The next target was to make observations about the soil maps green area, littoral deposit of unknown coarse material. The coarse material was defined as coarse sand (Figure 15, Area 6). The sand was well rounded and sorted. During the site walk, the following observations were made; there is a sharp contact between the sandy till and the littoral deposit coarse sand both in the Southern part of the deposit and sharp contact in the North, but sand is contacted in the North with a thin peat deposit. In S-N direction the dimensions of the littoral deposit are about the same as in the soil map. However, the Western border of the littoral deposit sand seems to be far more in the East than is marked on the map. A Littoral deposit in the West end up in the swamp like vegetation when the ground level drops.

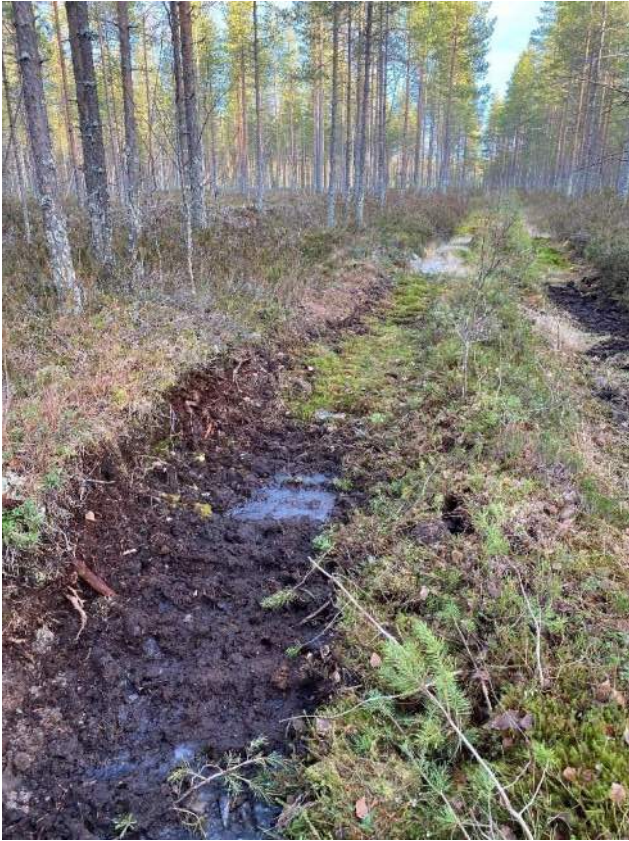
Figure 16. Coarse sand is widely exposed to the power line construction site.

The thin peat deposit which is located mainly East of the power line was visited near the end of the site road. The peat deposit was exposed because of heavy forest machinery (Figure 16, Area 4) and is located approximately where it is on the soil map.

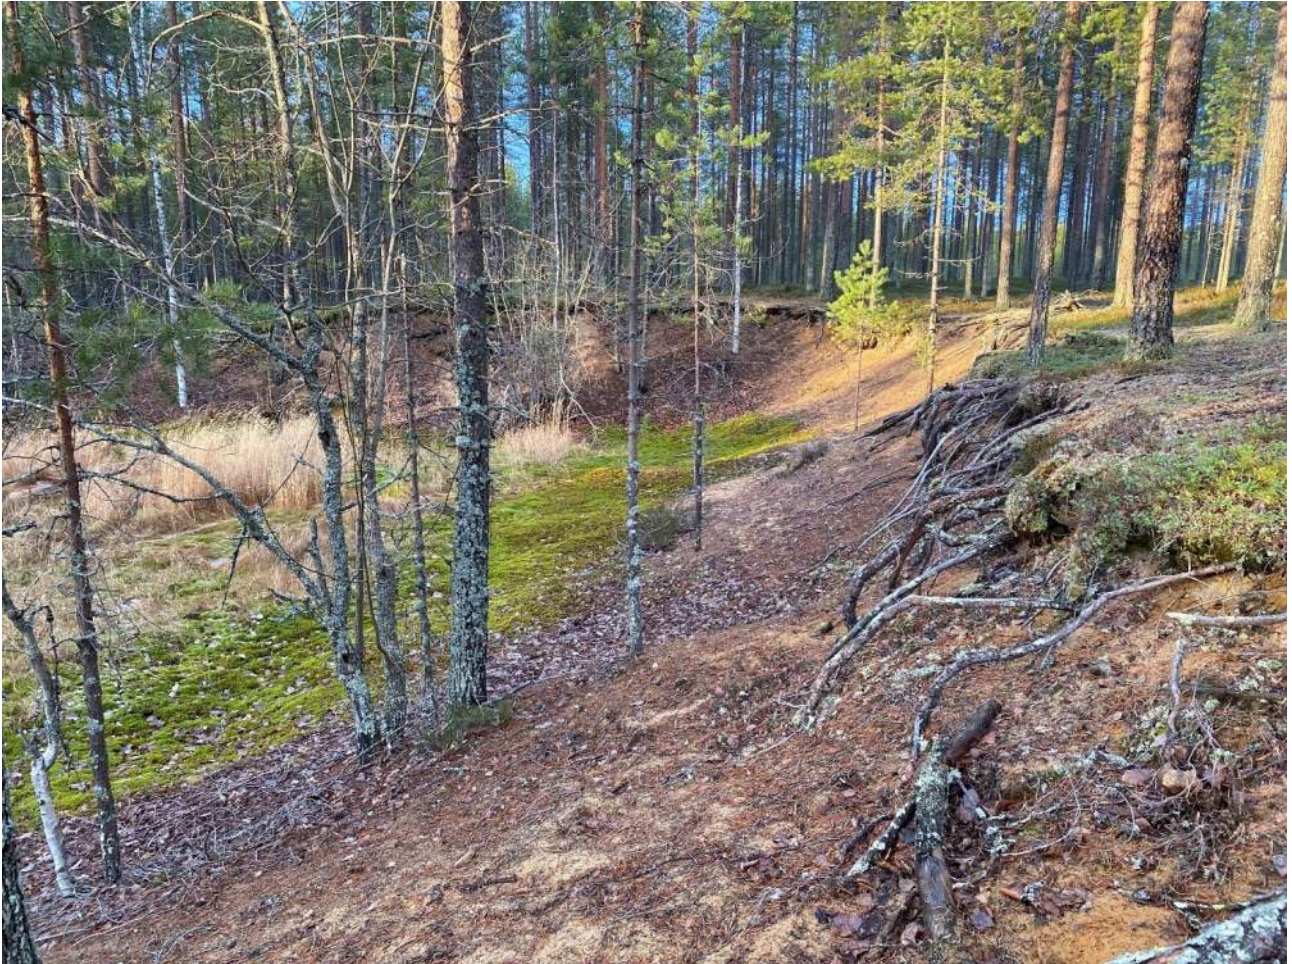
Figure 17. Figure from the “pond”. Fine-medium grained sand is exposed to the pit walls.

The next target was “the pond”, marked on the site map (Area 8). The pond seems to be an old sand pit (Figure 17). The surrounding area is left without bigger rocks (bigger rocks are common in the sandy till) and undulating surface with 50-150 m offset from the pit. This means that the sand area is estimated to be 200-300 m wide, about circular fine-medium grained sand deposit, probably littoral in origin. The sand is well rounded and sorted. The thickness of the sand in the pond is at least 3,5 meters and the sand deposit is probably getting thinner towards the deposit borders. The former digging probably stopped because reaching the ground water level after 3-3,5 m. These sand observations are marked to the soil map. The sand observation relates to TP5 surface layer sand. The drillings will tell more accurate information about the extent of the sand layer.

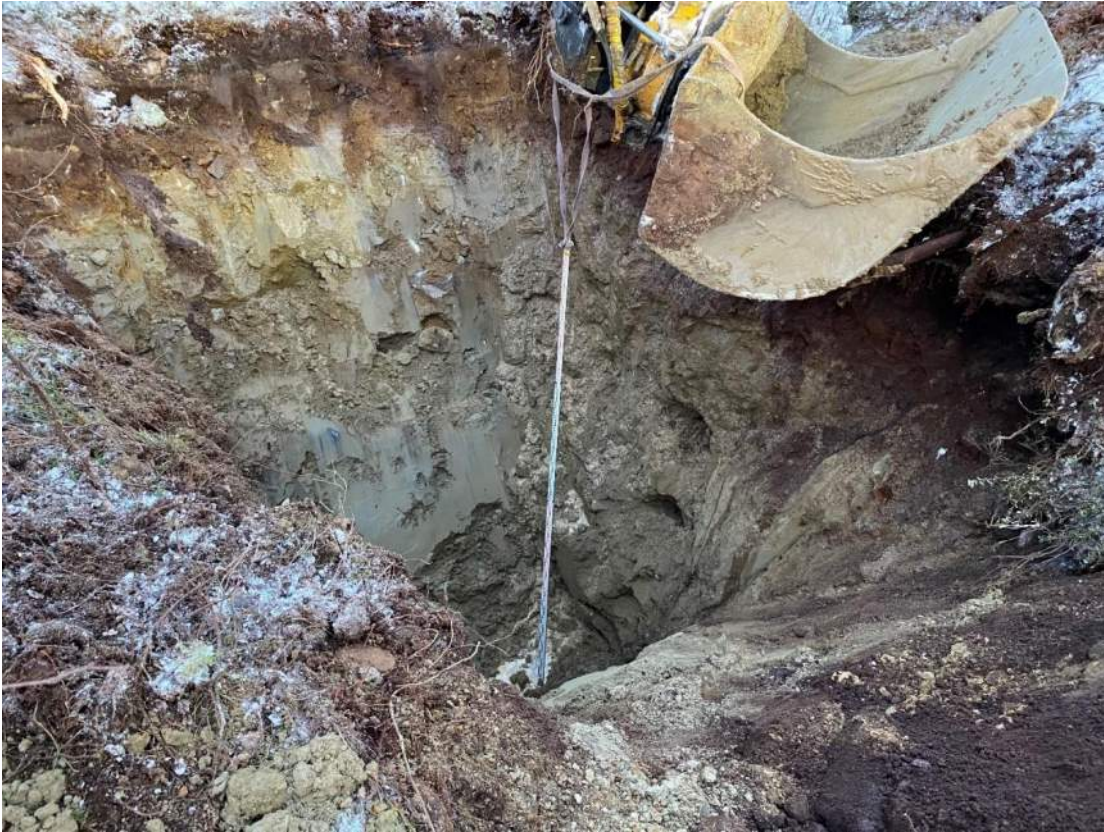
Figure 18. TP1 0-4 m peat, 0,4-0,6 m gravel, 0,6-5 m sandy till.

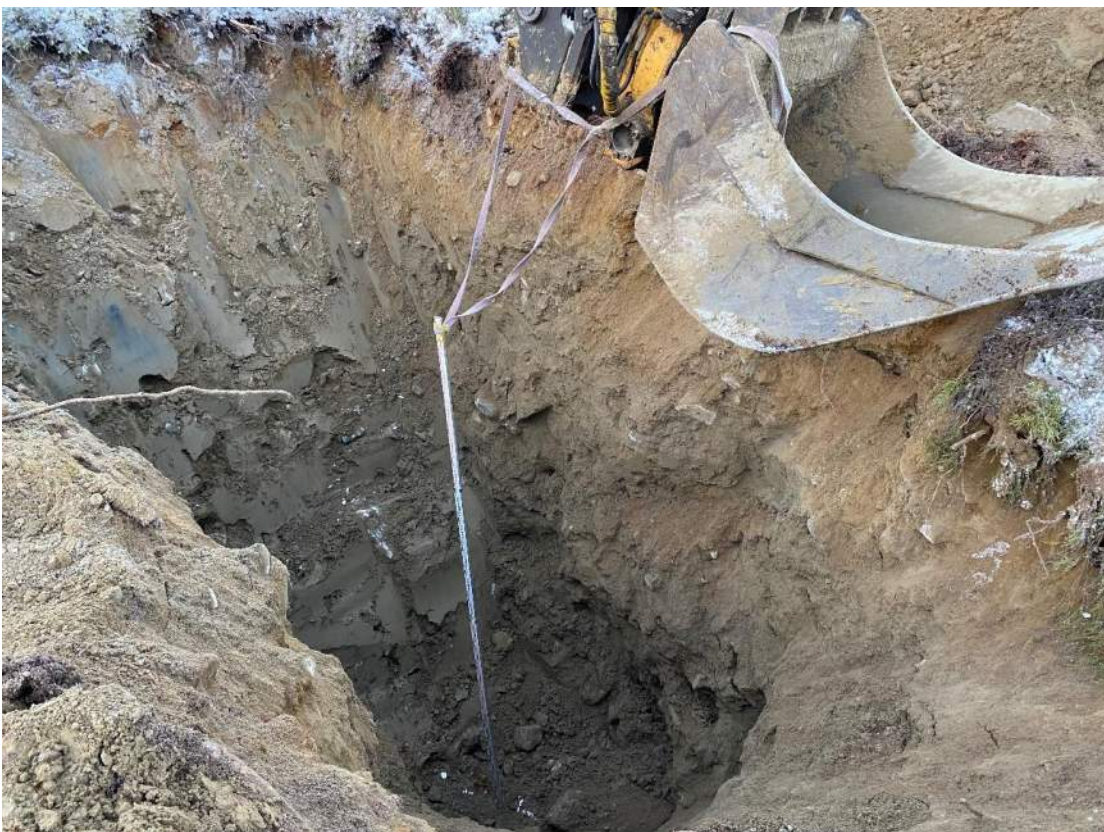
Figure 19. TP2 sandy till.

The TP2 pit confirms the soil map (Figure 19). The only soil layer is dry sandy till all the way to 5 m.

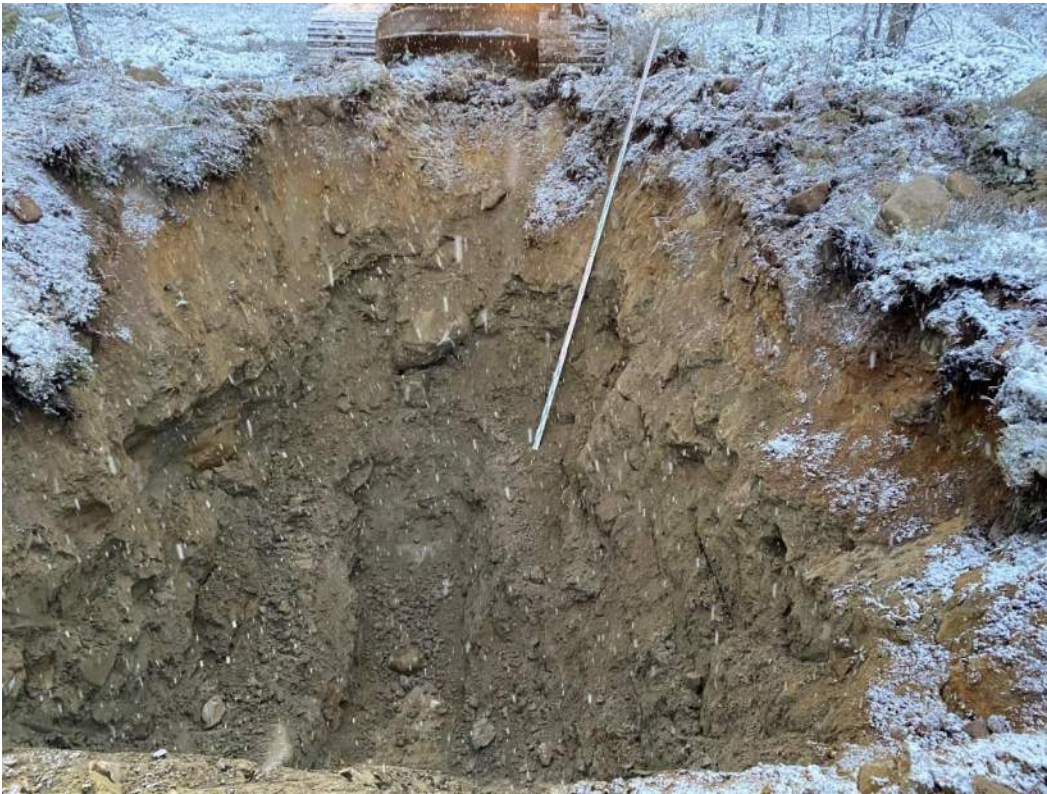
Figure 20. TP3 sandy till.

The TP3 pit confirms the soil map (Figure 20). The only soil layer is dry sandy till all the way to 5 m.

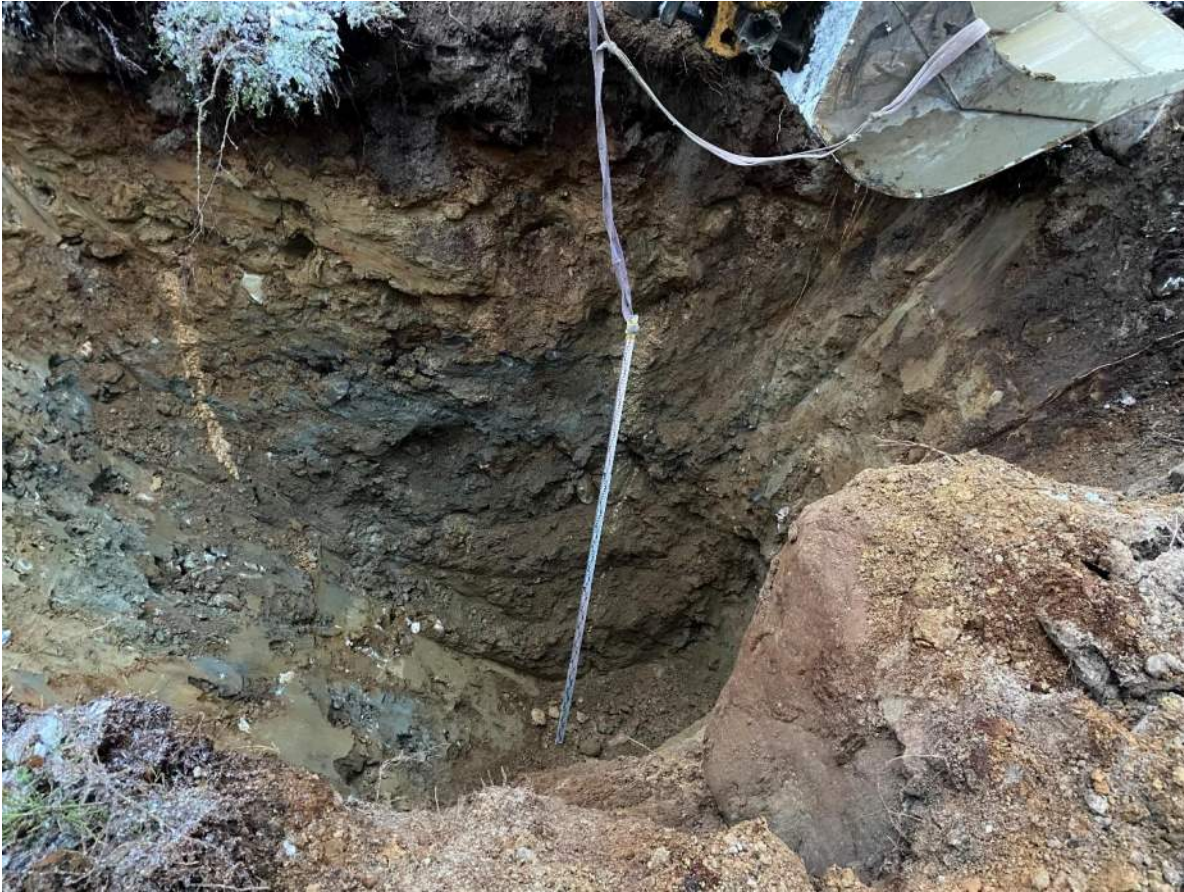
Figure 21. TP4 sandy till 0-1,8 m, silty till 1,8-5 m.

The TP4 pit was supposed to be located on a thick peat deposit, but surprisingly, the peat deposit was practically non-existent (Figure 21). The vegetation in the area was typical of swamps. The first soil layer was (0-1,8 m) sandy till. Then the moraine material changed to a more fine-grained silt/clay containing moraine. The surface water was flowing into the pit from the beginning, but groundwater started flowing in from 1,5 m. It is unclear where the peat layer is getting thicker, but the soil maps thick peat deposit is narrower than previously thought.

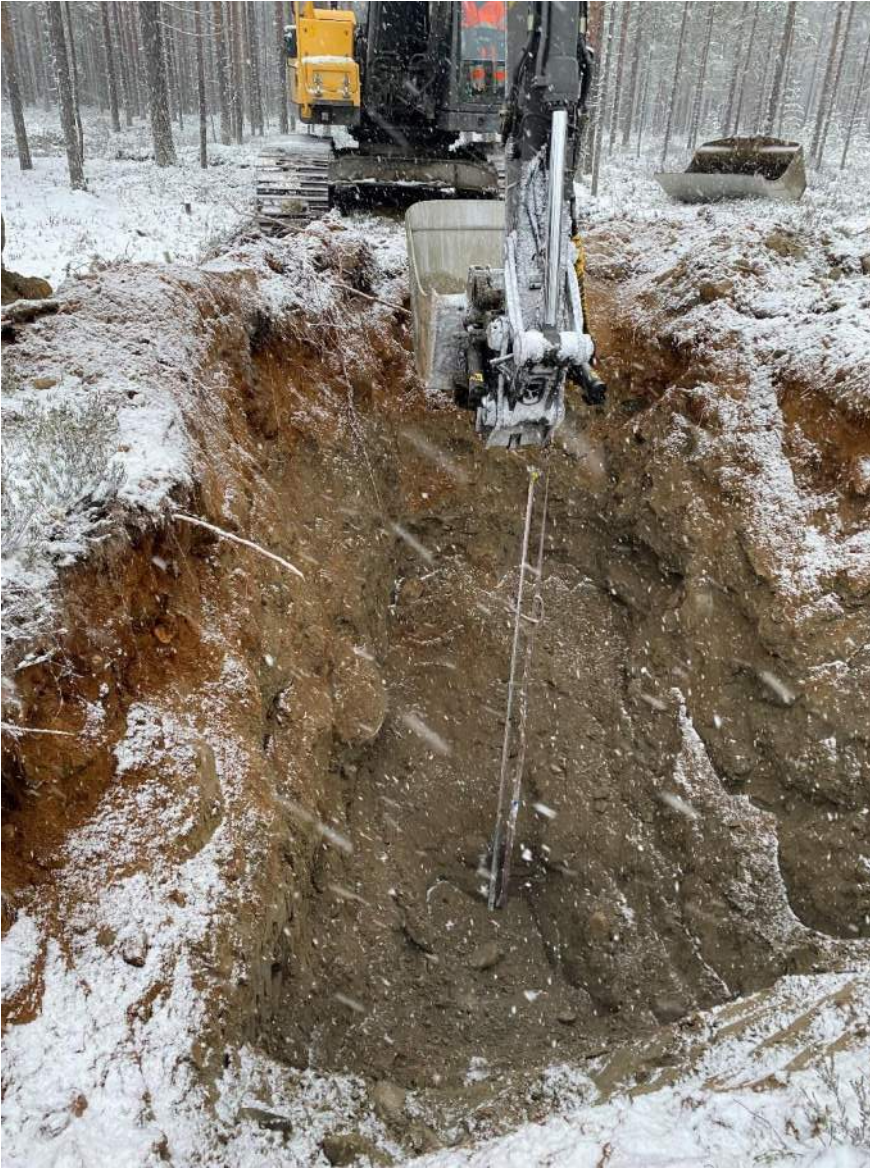
Figure 22. TP5 top layer consist of sand. Sandy till from 0.5 m.

The TP5 (Figure 22) pit shows sand in the top layer, which might be interconnected with the pond area observations. The sand layer is only 0,5 m thick with sharp contact to the sandy till layer. The pond area littoral deposit sand might therefore be wider than during the site walk was estimated.

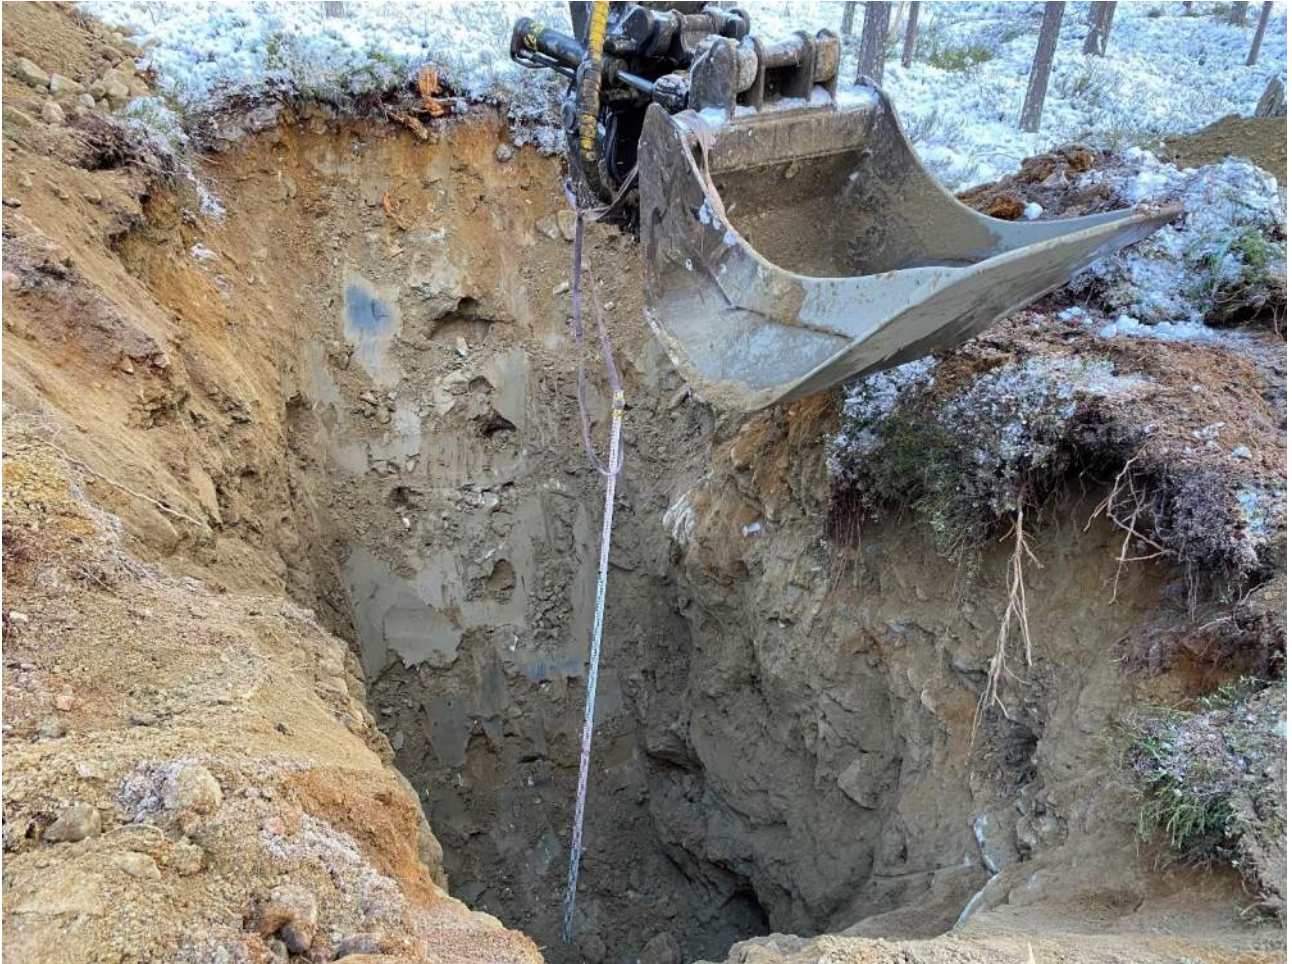
Figure 23. TP6 sandy till.

The TP3 (Figure 23) pit confirms the soil map. The only soil layer is dry sandy till all the way to 5 m.

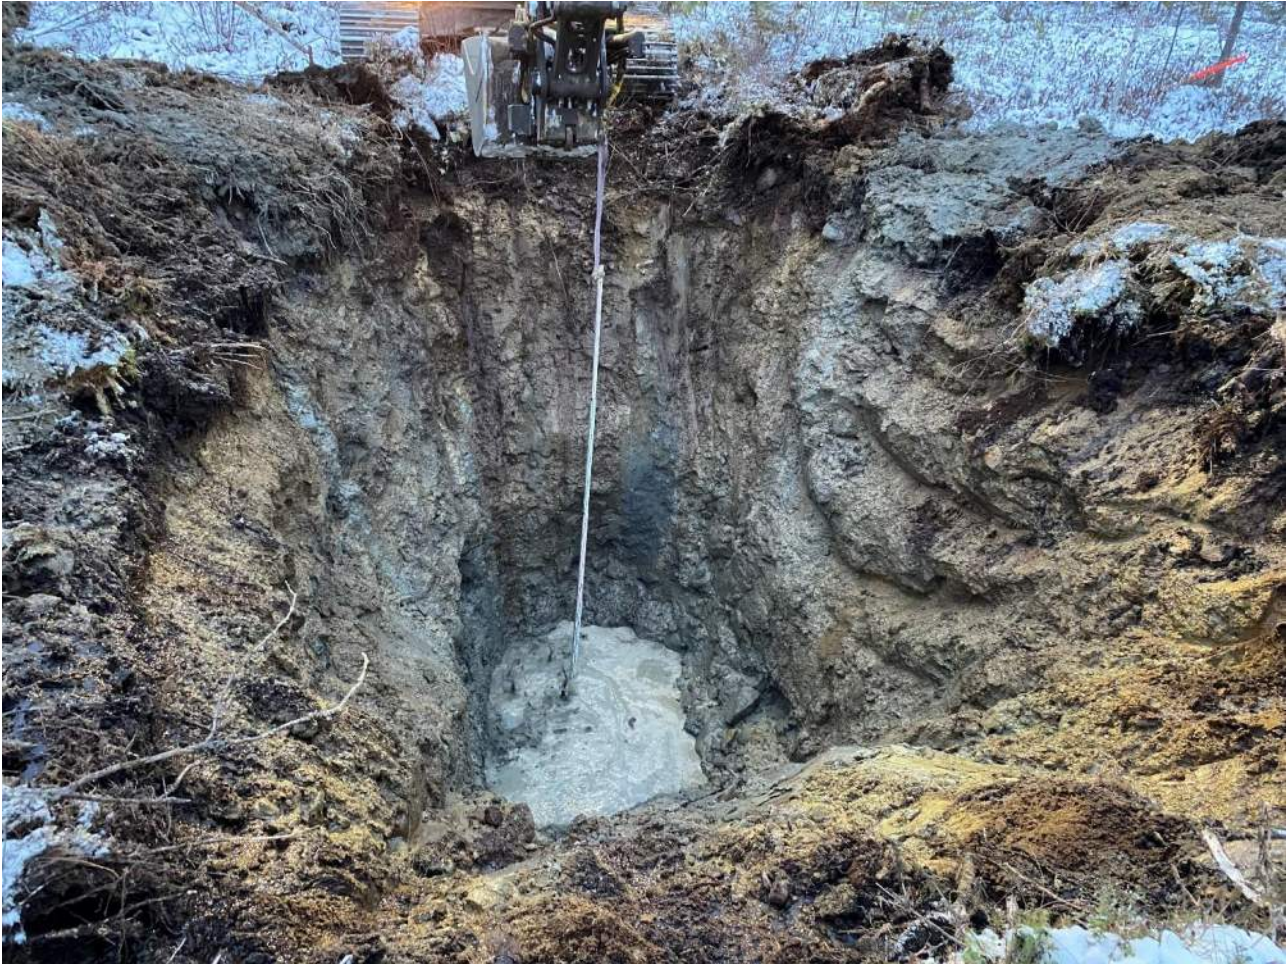
Figure 24. TP7 silty moraine.

The TP7 area looked like a swamp with a lot of surface water on the ground. The peat layer was almost non-existent here (Figure 24), but fine-grained material containing silty till was not letting the water through and therefore forming swamp. In the soil map, the TP7 area is marked as a sandy till, but according to field observations there is an area of unknown size silty till.

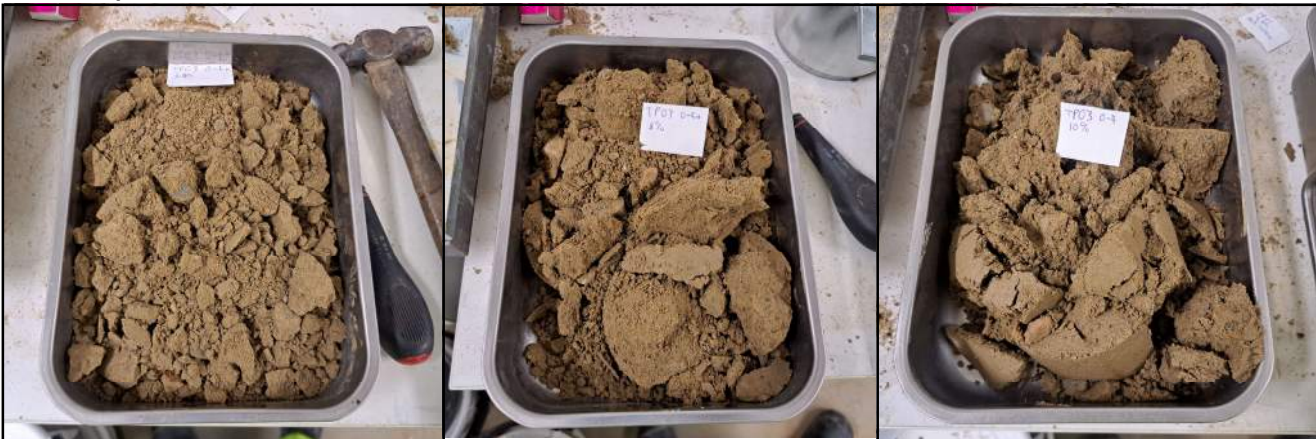
Possible photos

1	TP03 0-5m 5,8%
2	TP03 0-5m 8%
3	TP03 0-5m 10%
4	
5

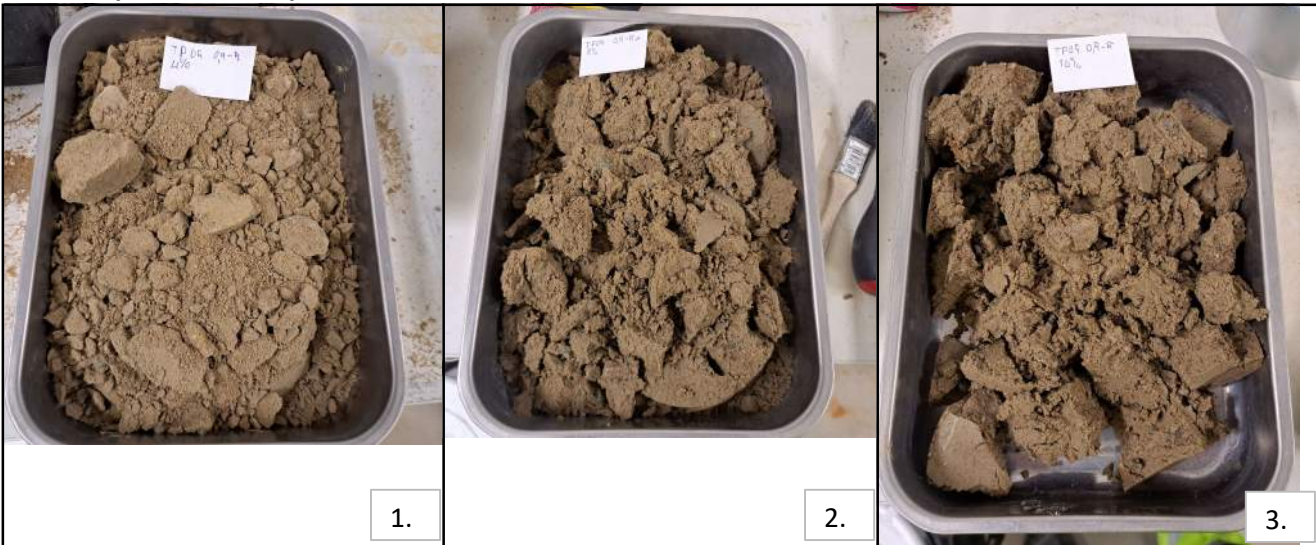
Possible photos of samples

<table><tr> <td>1</td> <td>TP05 0,5-5m 3,6%</td> </tr></table>

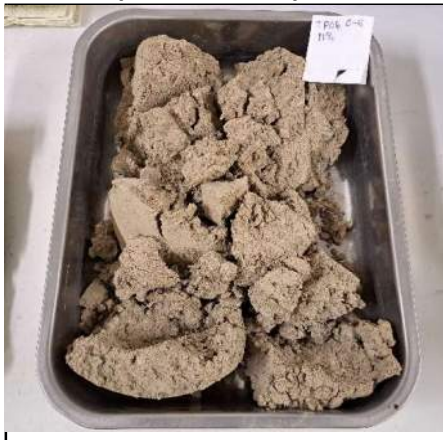
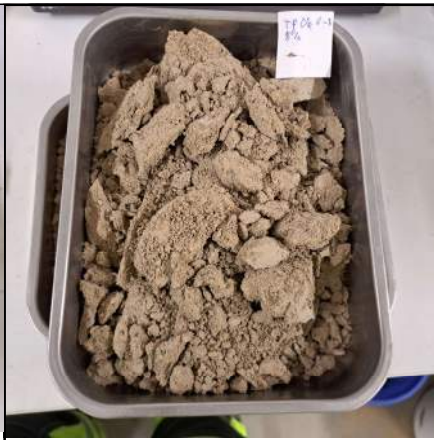
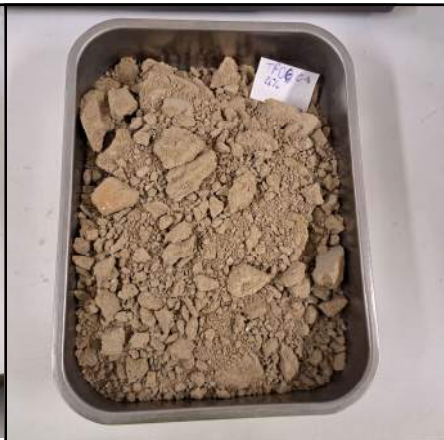
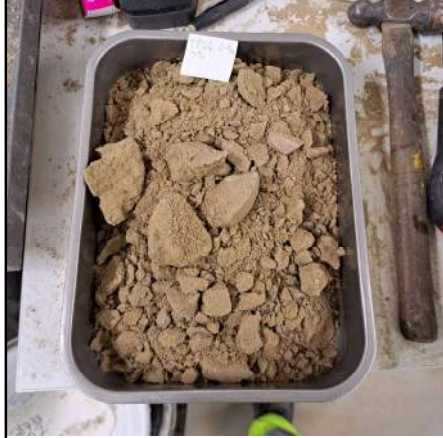
Possible photos of samples

<table><tr> <td>1</td> <td>TP06 0-5m 11%</td> </tr><tr> <td>2</td> <td>TP06 0-5m 8%</td> </tr></table>
